NSK TOUGH STEEL BEARINGS  
LONGER LIFE IN  
HEAVY INDUSTRIES

# TOUGH STEEL: BACKGROUND AND DEVELOPMENT

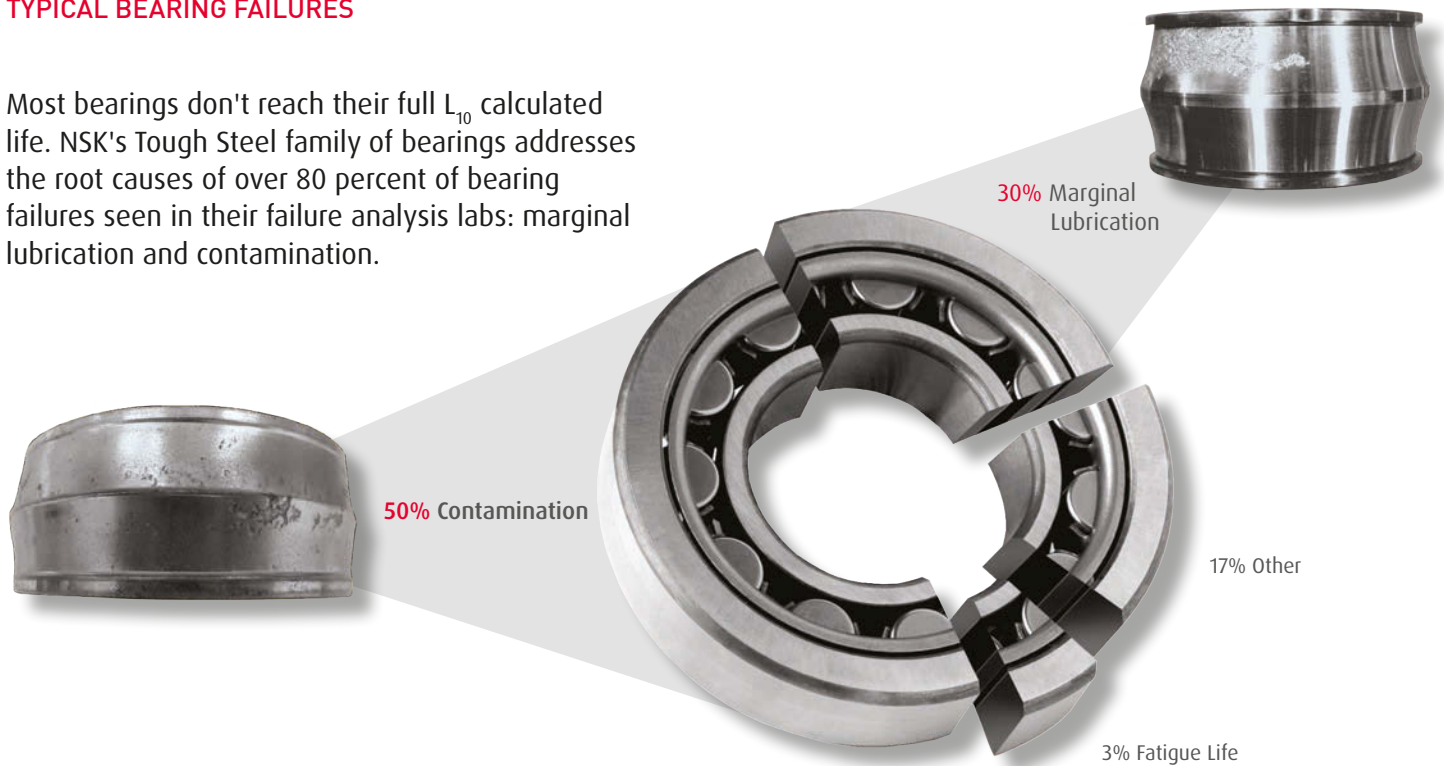
Most bearings don't reach their full  $L_{10}$  calculated life. NSK's Tough Steel family of bearings addresses the root causes of over 80 percent of bearing failures seen in their failure analysis labs: marginal lubrication and contamination.

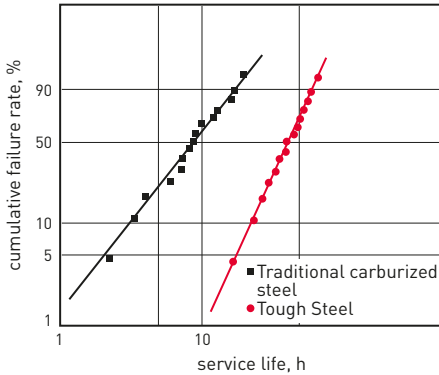
Service life of L446649/10 bearings under **contaminated** lubrication conditions

Test conditions:  
 P/C=0.43, Oil bath  
 Speed: 4000 min<sup>-1</sup>  
 Debris: Hardness HV870  
 Size 74 to 147mm  
 Amount 150 ppm

**7x life over carburized steel**

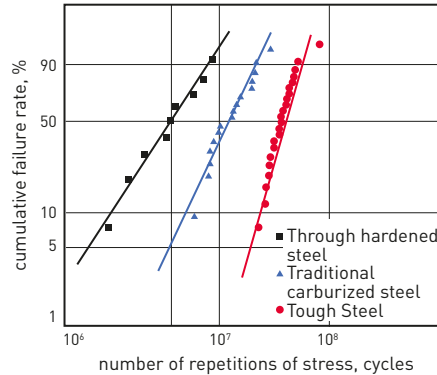
Service life tests of 6206 bearings under **marginal** lubrication conditions

Test conditions:  
 Pmax: 4400 MPa  
 Oil bath,  $\lambda=0.3$   
 Speed: 7800 min<sup>-1</sup>

**4.7x life over carburized steel**

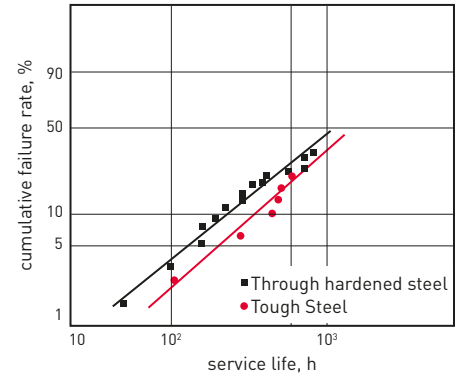
Service life tests of 6206 bearings under **clean** lubrication conditions

Test conditions:  
 P/C=0.71, Oil bath  
 Speed: 3900 min<sup>-1</sup>

**1.5x life over through hardened steel**
